Status of FPIX Production

A.Hahn

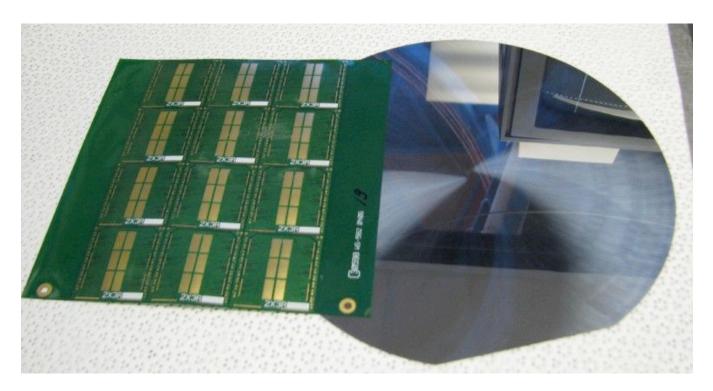
VHDI Production

- •Flex circuit laminated to 300 μ Si Wafer with 3M9882 (50 μ thick) Thermally Conductive Adhesive Tape
- Probe Tested at KSU for electrical faults
- •We were working out Lamination Issues at time of last PMG
 - Now solved

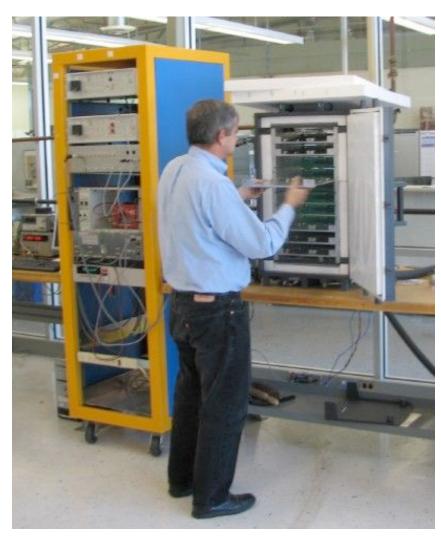
Plaquette Testing- Burn-In Box

- •Each shelf can hold:
 - •2 Plaquette Carriers for 20 in total
 - •1 Panel carrier
 - for 10 Panels in total
 - Current Setup
 - •7 Plaquette, 3 Panel Shelves
- •10 Temp cycles between ~20<->-15°C
 - •2 day period
 - •LV and HV on
 - Modest testing runs continuously
- Currently in production
 - >160 plaquettes have been processed
 - No plaquette has yet failed during the burn-in
- •Weekly rate (3 runs) 42 Plaquettes, 9 Panels

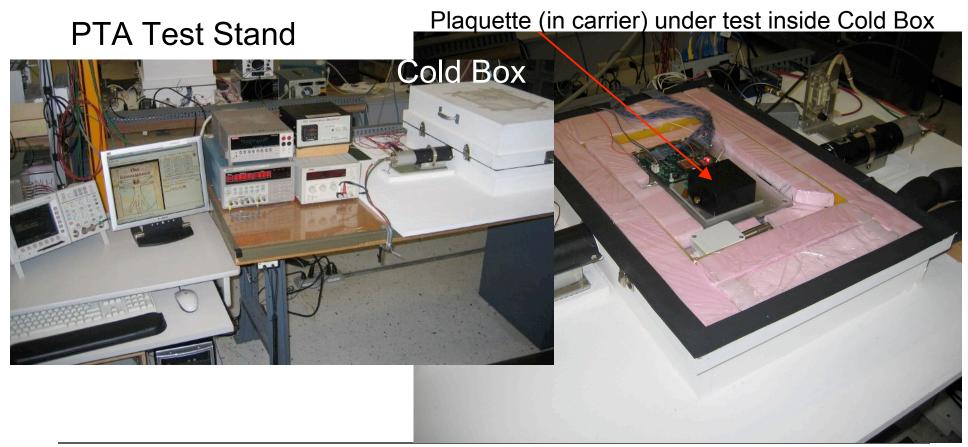
Plaquette/Panel Testing

- •2 test Stations for Plaquettes (8 Plaquettes/day)
- •1 test Station for Panels (2 Full Panels/Day)
- Easily handles full Purdue Production rate (6 Plaquettes/day)

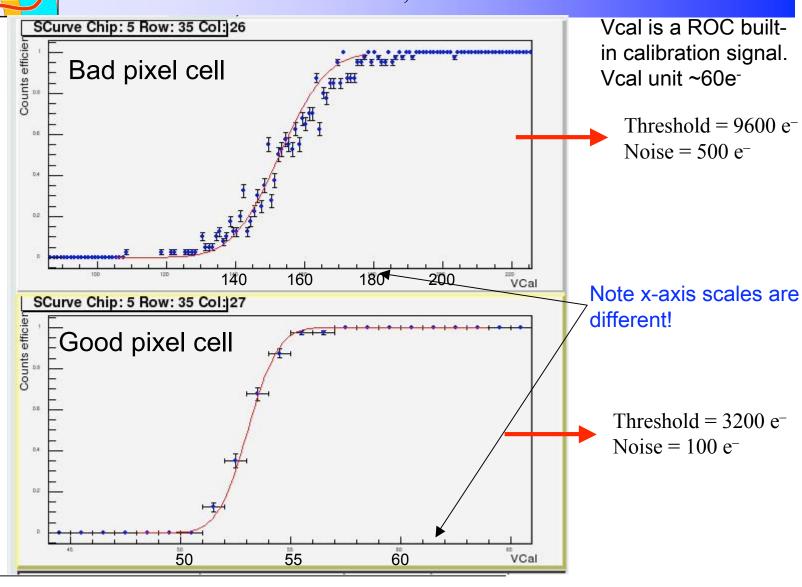
"IZM Effect": Comparison of a good and bad cell of chip5. Fix threshold, scan Vcal

- 38 "C" (32 IZM, 6RTI)
 - 27 of the 38 "C" graded plaquettes are due to a bad IZM processing step
 - Problem exhibited by low gains/high noise in many pixels in specific ROCS

- Noticed these ROCs were came from the same geographic region of the wafer.
 - Verified effect with movable pulse Laser aimed into Sensor cells
 - 5 have breakdown issues (3 RTI, 2 IZM)

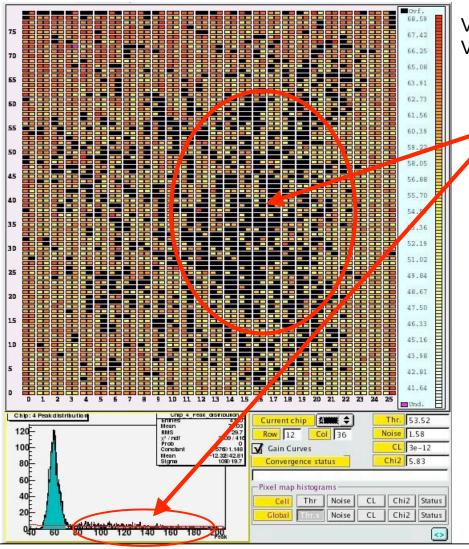
Threshold dispersion of chip4, Fix Common Threshold @~50 Vcal units for entire chip, scan Vcal

Vcal is a ROC built-in calibration signal. Vcal unit ~60e⁻

Black Pixel = very high threshold

It is clearly evident the region of the ROC were the threshold of the pixels is much higher.

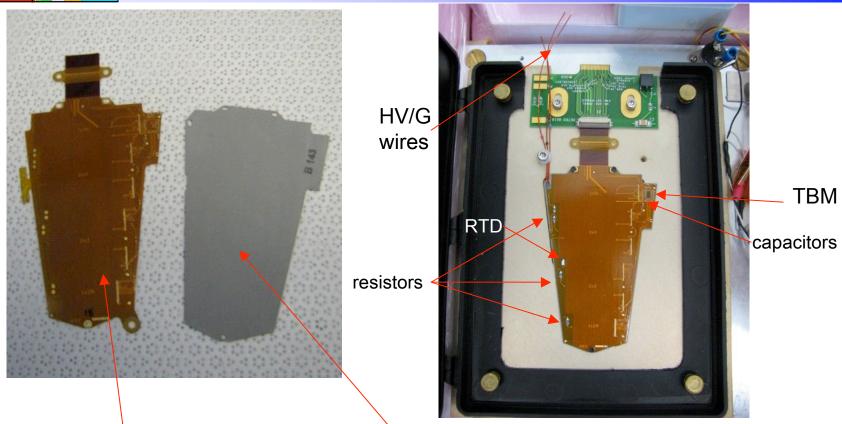
"Bare" Panel Production

"Bare" 4R_{ight} Panel on Panel carrier

- Flex Circuit laminated to 500μ thick Be plate with 3M9882 (50 μ thick) Thermally Conductive Adhesive Tape
- Bare Panel = Populated (resistors, capacitors, RTD), Wires soldered, TBM attached, and wirebonded

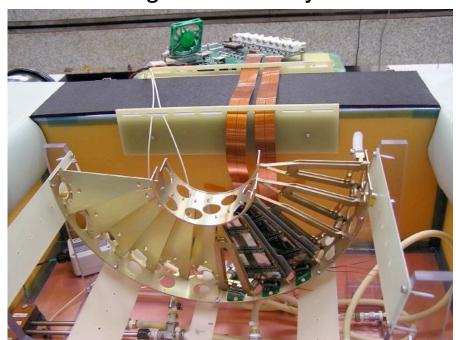
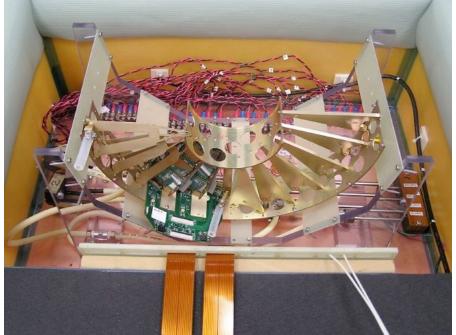
2007 Pilot Run HalfDisk Assembly

- •2007 Pilot Run Panels are ready (8 total)
- •All are now mounted onto the two 2007 Half-Disks
 - Cooling and electrical tests underway
- < 2 hrs to mount 4 panels on 2nd Half-Disk
 - •~1 day to mount 24 panels on Production Detector
- •Plan for Pilot run Detector to be completed end of November 06 and shipped to Tracker Integration Facility at CERN

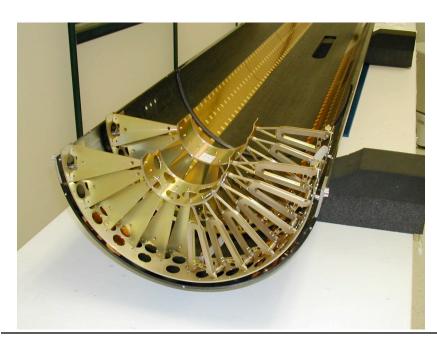
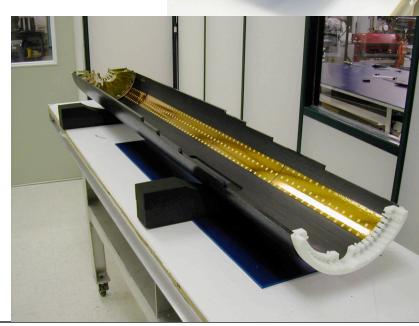
•2007 Pilot Run Detector Half-Disk Mechanics

Mount support electronics and half Disks into 1/2 Service Cylinder

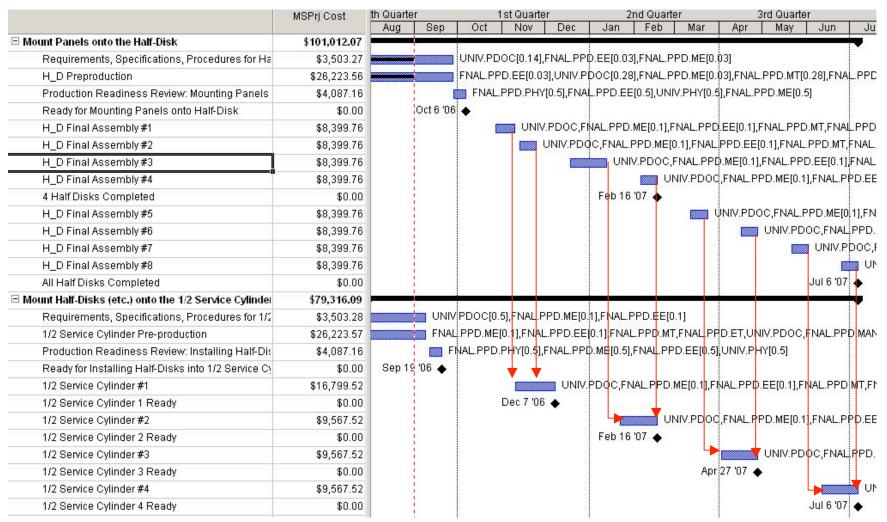
Final Assembly Schedule (from Aug.06)

Gaps are set by Plaquette Production rates and scheduling (wait to make panels until all plaquettes for that panel's HD are tested). This gives some more schedule float.
